High-Quality Tooling or Rock-Bottom Cost?

Walter Freischlad, Consultant to
B&H Tool Company, Inc.
285 Pawnee St.
San Marcos, CA 92069 USA
www.bhtool.com

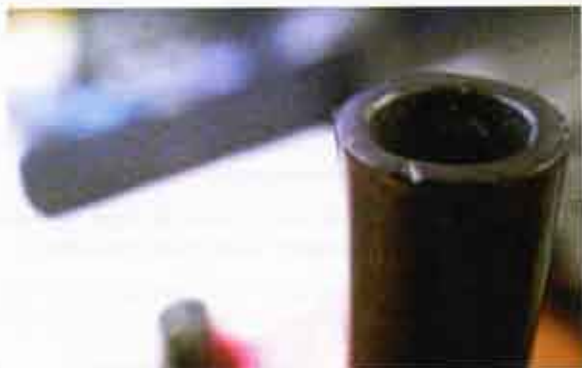
A worn or damaged tip can impact product quality, reduce productivity and create hidden costs that include material waste, troubleshooting and inspection.

A major hidden cost that is a direct result of using worn or damaged tooling is excess material. When tooling begins to wear or is cleaned with abrasive material, the OD of the tip is reduced, and/or the ID of the die increases. In this case, operators often run on the high side of OD tolerance because it is easier to overcome extrusion problems. Since most tolerance specs have a reasonably wide range, a manufacturer's ability to hold tight tolerances on the low end can significantly reduce material cost. In this case, the raw material savings alone often justifies an investment in optimal tooling, particularly for those making large quantities or extruding high-priced material such as PFA or FEP.

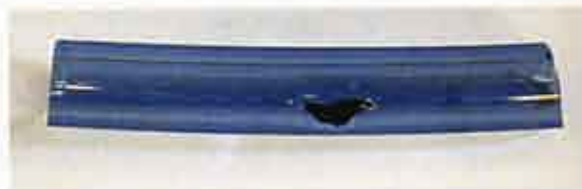
Burned material is discharged into the product wall creating a material defect.

The most visible problem caused by worn or damaged tooling is product quality. When a tool set is worn, or acquires dents, nicks and scratches, it will hold up material. This material will burn over time, eventually slip out and create black spots in the insulation. These spots often become enough of a problem to require an extra inspection. In virtually every case, the result is added labor cost and scrap.

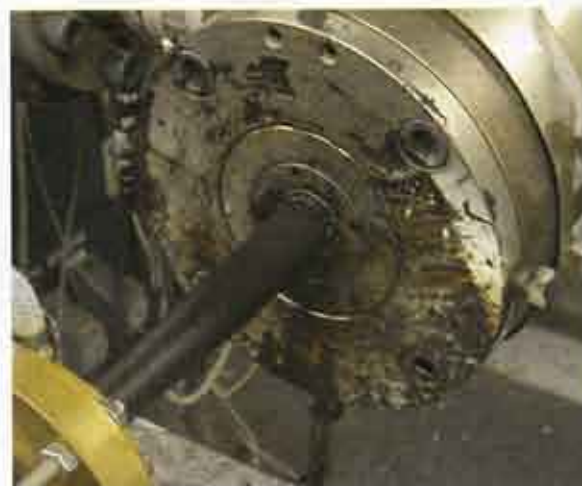
Improper tooling maintenance leads to excessive cleaning and downtime.

To solve this, you might choose to clean more often. That seems to make sense, except it means you have to stop the machine, take the crosshead apart, clean the tooling, put it back together and restart. So, you save US\$1000 by not

replacing the damaged tool set. However, the costs associated with having your extruder out of commission for 30 minutes to two hours every time it needs to be cleaned can be staggering. Over time, the avoidable costs of downtime and lost productivity will substantially exceed the cost of new tooling.
